Volume 38, No. 8
August 1976

BEACH EROSION ON SILETZ SPIT, OREGON

Paul D. Komar and C. Cary Rea
School of Oceanography, Estuarine and Coastal Research Program
Oregon State University

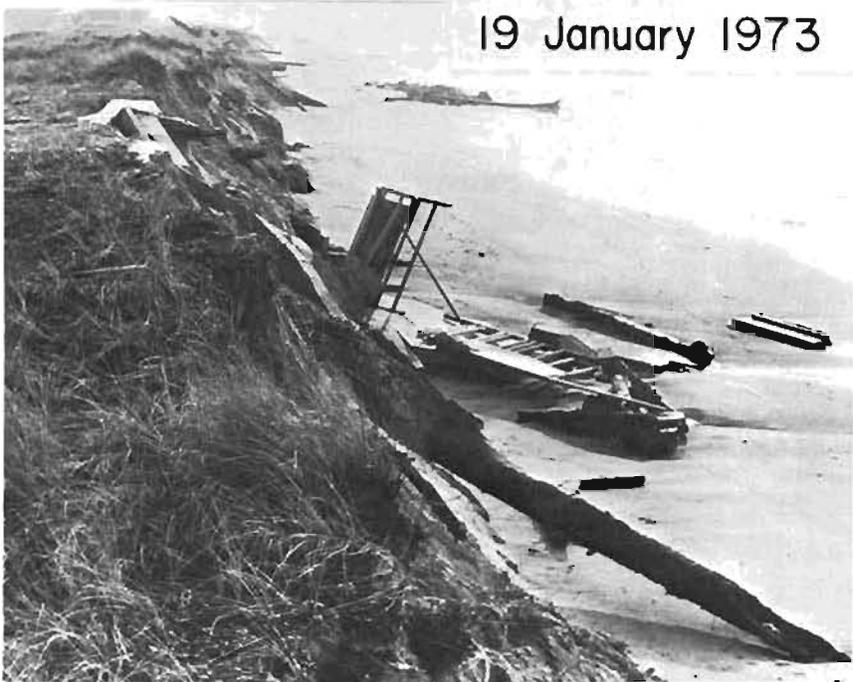
Figure 2. Erosion and destruction of the house under construction on lot 226 of Siletz Spit.

The severest episode of erosion occurred during the winter of 1972-73. One partially built home was destroyed (Figure 2), and others had to be protected by riprap on three sides (Figures 3 and 4). The worst erosion took place along a 650-meter stretch of the central spit, opposite the artificial lagoons cut into the bay side of the spit. Figure 5 diagrams the erosion to the base of the foredunes, the maximum recession amounting to 30 meters in a 3-week period. Individual homeowners placed riprap in front of their properties, but unprotected vacant lots continued to erode. Flank erosion in the empty lots made it necessary to protect the sides of houses so that the group of three houses ended on a promontory supported by riprap (Figures 3, 4, and 5).

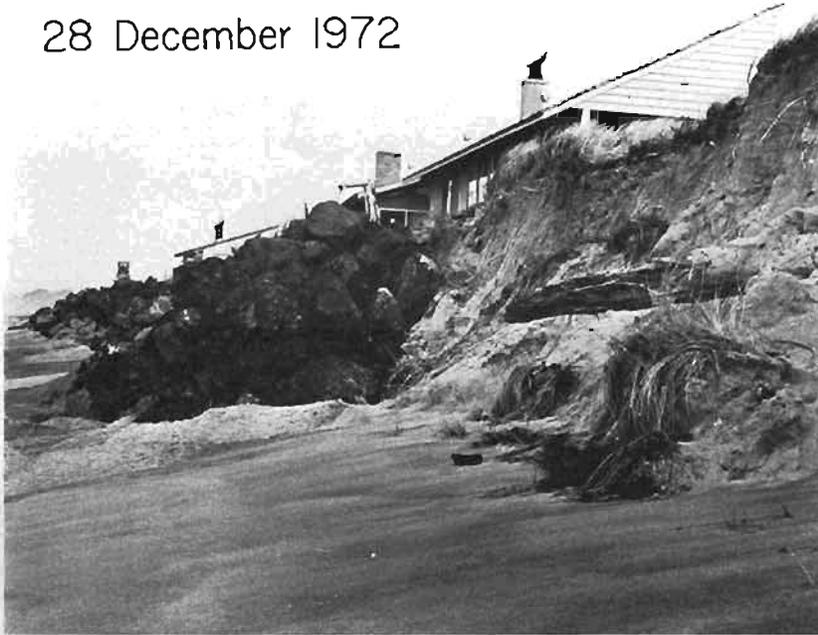
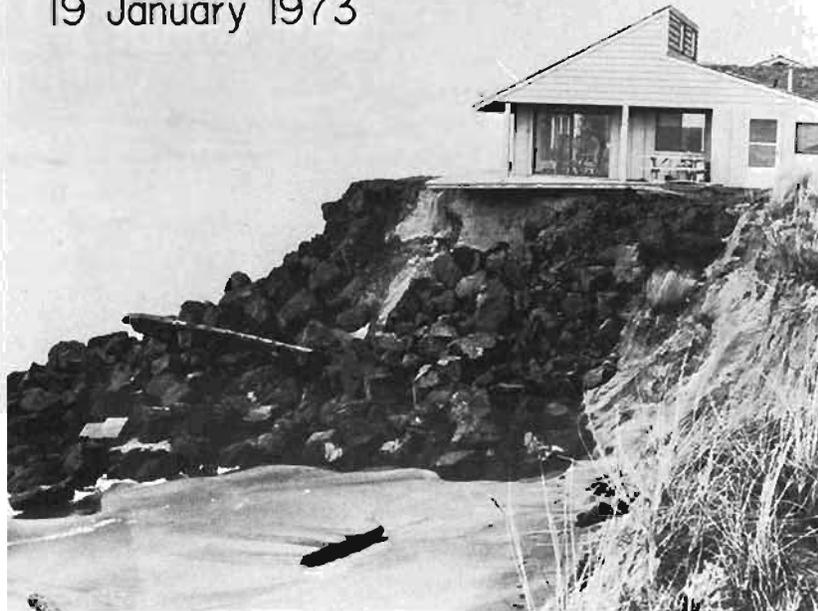
Figure 3. Erosion around the house on lot 229-A. Rapid erosion required placement of riprap fronting home in upper photo; but no riprap was installed in adjacent vacant lot, so erosion continued along the side as seen in lower photo.

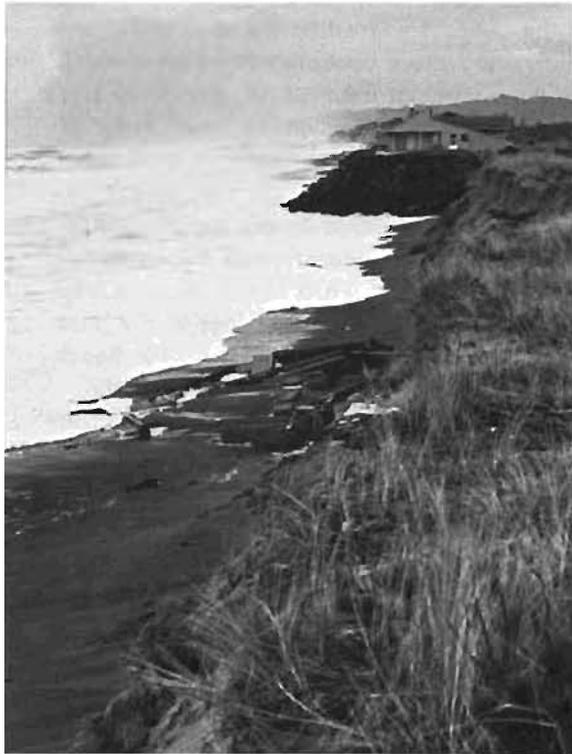
Figure 4. View of both houses of Figures 2 and 3.

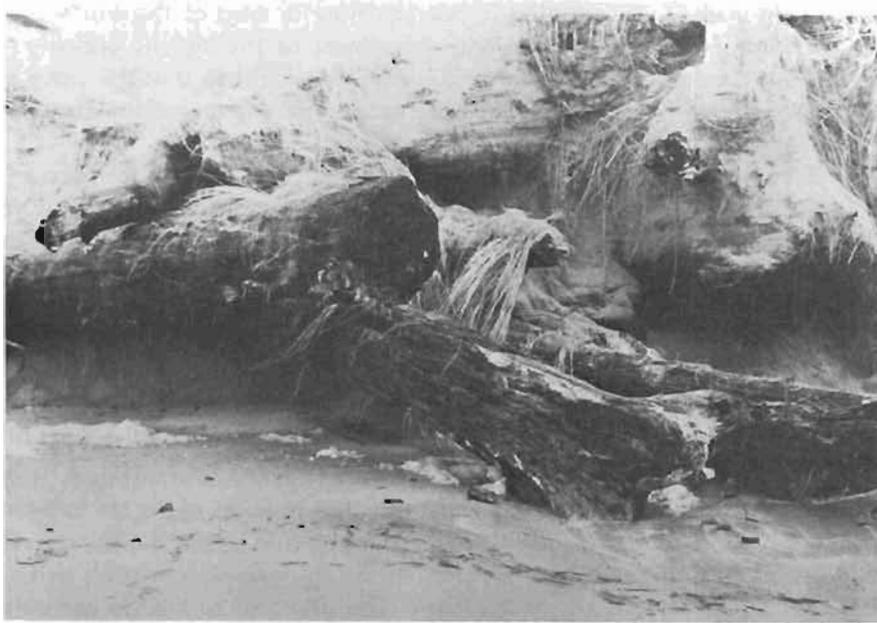
Figure 6. Logs exposed within the eroded dune bluff, many of which had been sawed.

Erosion of the dunes of the spit exposed numerous drift logs, many of which had been sawed (Figure 6). This indicates that spit development was contemporaneous with logging along the Oregon Coast. The influx of settlers and logging started about 1895. Sawed logs within the spit indicate that the portion on which the houses had been built suffered previous erosion some time after 1895. The dunes must have then built back out, incorporating sawed logs in the process, and become re-established.

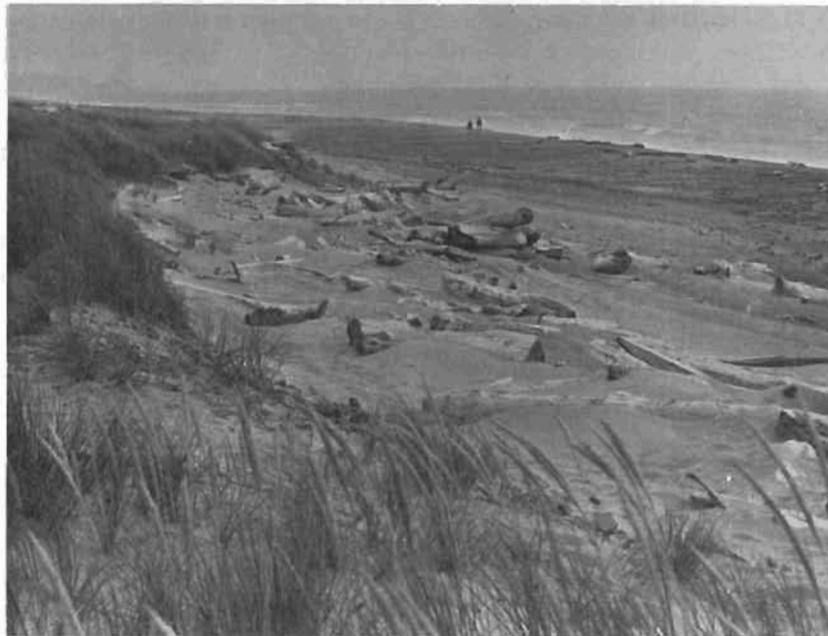
Figure 7. Logs deposited within small embayments eroded into the foredunes trap sands and help reestablish the foredunes.

This study also demonstrates that drift logs play an important role in the natural rebuilding of the foredune areas on spits (Figure 7). Large-scale removal of logs from these areas may be harmful.

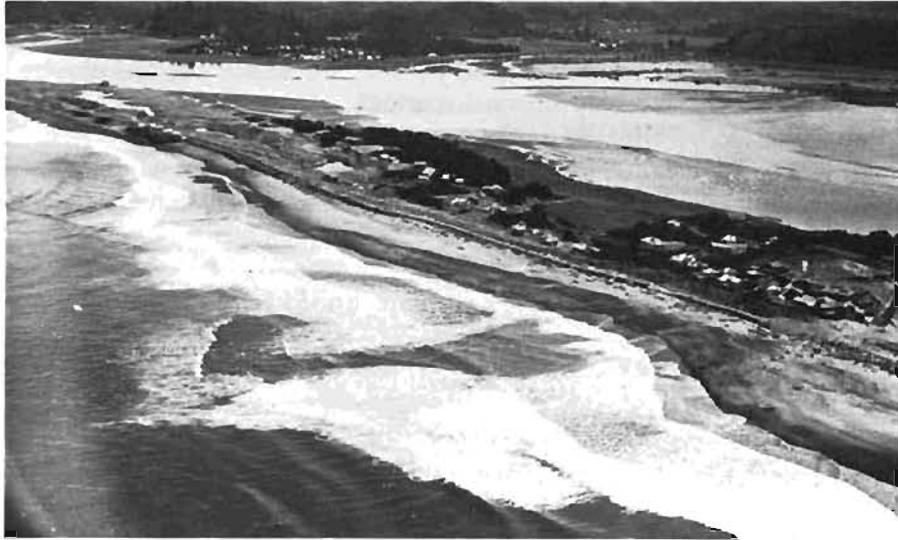
Figure 8. Irregular shoreline of bays and cusps are due to rip currents, one of which is shown in this photograph taken February 8, 1973.

The shoreline along Siletz Spit is typically very irregular (Figure 8) due to rip currents carrying sand offshore, hollowing out small bays on the beach with large cusps between them. At the time of erosion in 1972-73

a strong rip current was situated in one position for most of the winter. This rip current hollowed out a large embayment on the beach, entirely removing the portion of the beach above high tide level so that the wave swash was able to reach the dunes. The loose sand, offering no resistance to the waves, was easily eroded.

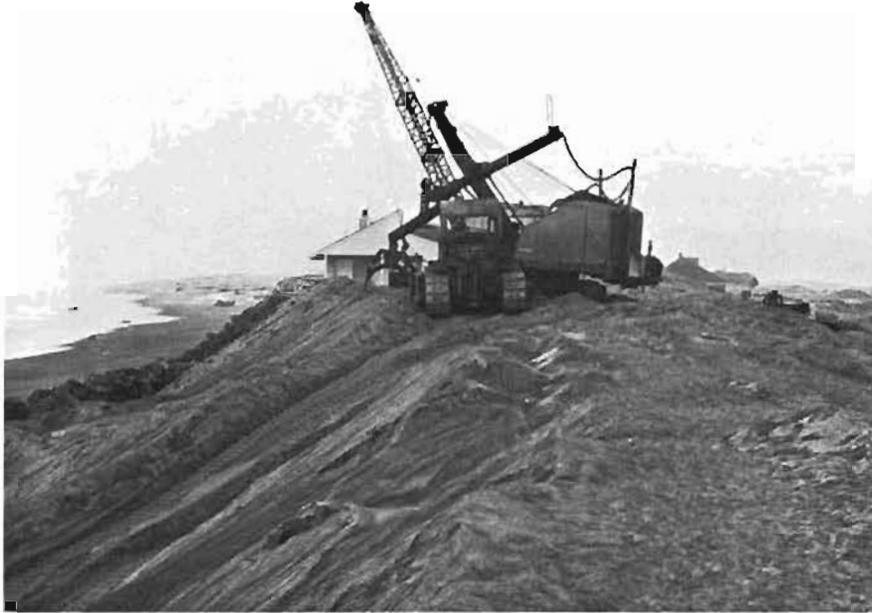
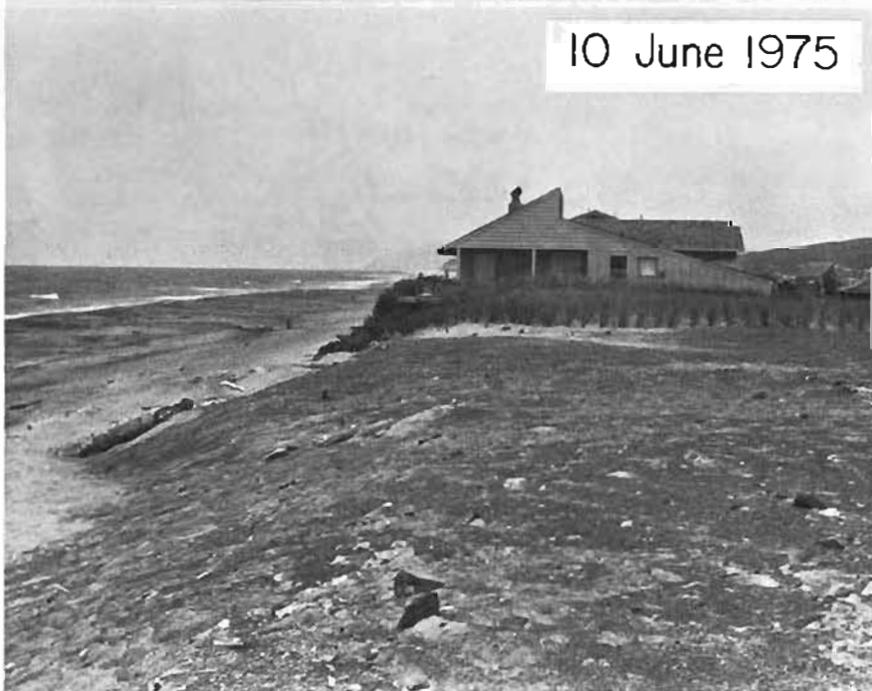
Figure 10. Restoration of the lots 228 and 229. Compare with Figures 3 and 4.

Some of the lots that were eroded in 1972-73 have been subsequently restored (Figure 10). These are either not protected or are inadequately protected: another winter of intense storms could bring renewed erosion. During this winter (1975-76) no rip current is located offshore from this area, and there is no erosion.

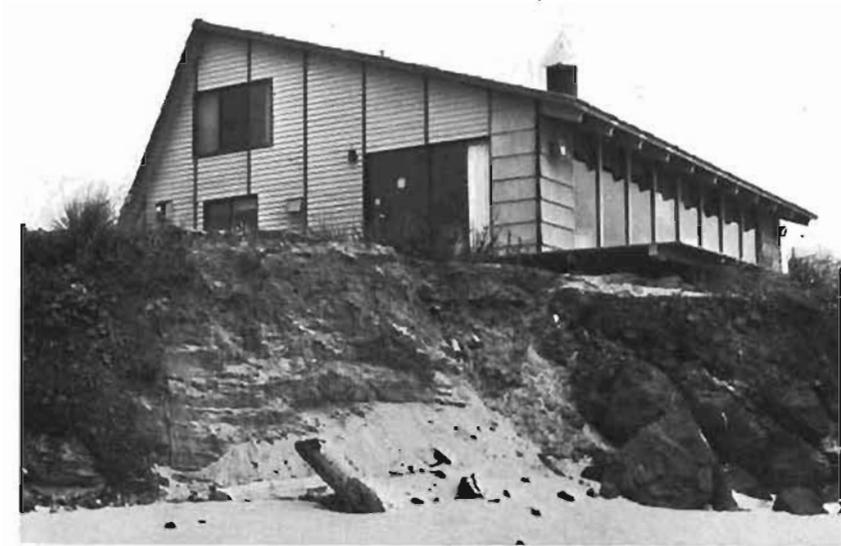
Figure 11. Erosion of the riprap fronting one of the homes, exposing some of the dune sands. Note small size of the rocks, which are easily removed by erosion.

Some houses for which riprap was installed in 1972-73 could be endangered by future erosion because the riprap protection is inadequate. In some cases the riprap has partially eroded, exposing the dune sands (Figure 11). This riprap was installed hastily in order to save the houses at the time of severe erosion in 1972-73, and installation did not follow the established engineering procedures for riprap construction. Even more important, stones of inadequate size were used because of their availability: these are easily washed away by waves.

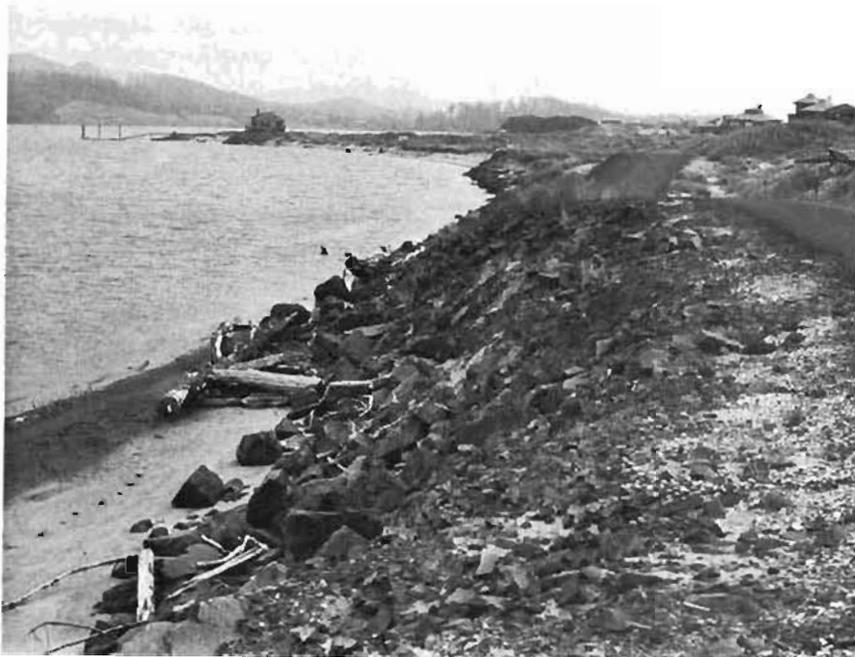
Figure 14. Riprap placed on the bay side of the spit to prevent or decrease erosion.

In 1875 the width of the spit, C, was 163 meters. By 1939 it had decreased to 102 meters. Now it is only 52 meters wide. The progressive increase in the distance B across Siletz Bay shows that the 111-meter decrease in the spit width was due entirely to erosion on the bay side. The edge of the foredunes (taken as the seaward limit of the spit width) fluctuated somewhat in position due to the cycles of erosion and dune reformation discussed above but did not change its overall position in those 100 years. This is reflected in the irregularity of the distance D in Figure 13. The erosion on the bay side appears to have been fairly steady until recently when riprap was installed to stop the erosion (Figure 14).

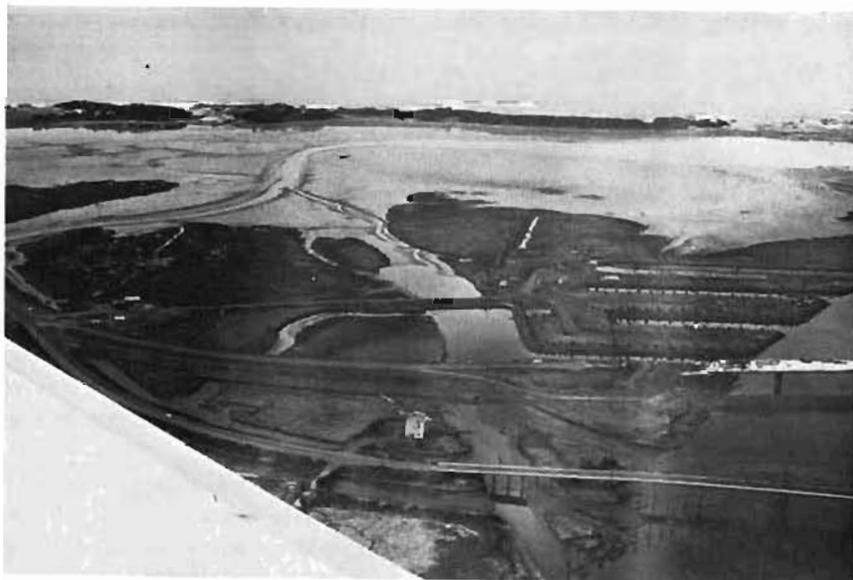
Figure 15. Aerial view of the Siletz Keys fill and the approaches to the old and the new highway bridges. Note how the access road to the Siletz Keys and the approach to the new bridge both block the channel leading to the south bay.

Recent landfills in Siletz Bay (Figures 12 and 15) have probably aggravated the erosion problem. Both the Siletz Keys fill and the dike on the Millport Slough prevent flood discharge spill into the south bay. Prior to these fills, flood waters flowed in part into the south bay, dissipating their energy. Now that the fills prevent this spill, the full flood discharge of the Siletz River is directed toward the back of the spit into the area that is eroding. Riprap has reduced the expected increase in erosion, but whether the riprap will continue to be effective is questionable.

Removal of the dike on the Millport Slough would partly eliminate this aggravation and would improve water circulation in the south part of the bay. Removal of the dike-entrance to Siletz Keys is no longer sufficient because the recent construction of a new bridge for Highway 101 over the Siletz River has also blocked that spill channel (Figure 15). A conduit under the approach to the bridge would also be necessary.
